PZL/IAR P.11F ROMANIAN FIGHTER

ON SKIS

MICHAŁ SKAWIŃSKI

COLOUR OPTIONS FOR IBG MODELS KIT No. 72522

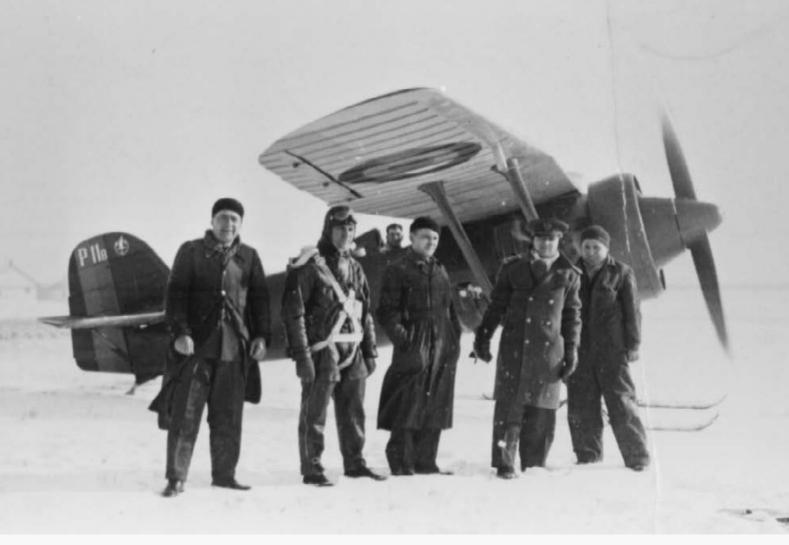
Long, narrow skis of I.A.R. manufacture fitted to P.11B in the winter of 1936/37. (Dan Antoniu/Horia Stoica collection)

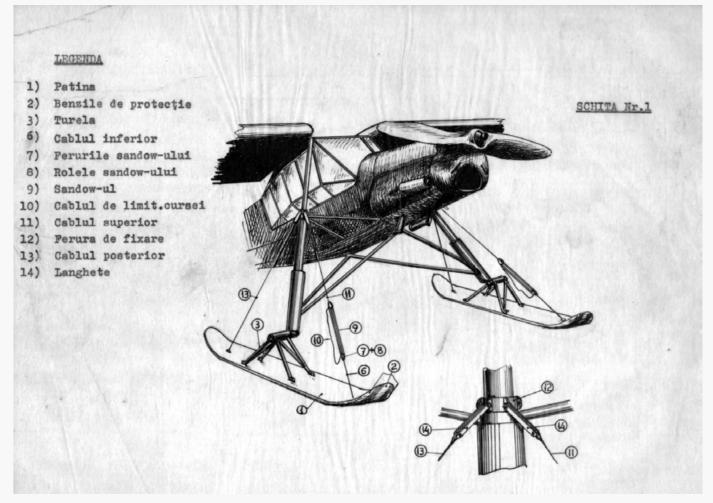
Skis produced by ICAR company installed on Fi-156 (version without aerodynamic fairings). Visible are the N-shaped truss and three metal reinforcement strips on the underside of the skids. The components described are almost identical to the skis on the P.11F. 1 – skid, 2 – protective strips, 3 – turret (called N-shaped truss in the eBook), 6 – lower wire, 7 – expander ferrules, 8 – expander rollers, 9 – expander (elastic rope), 10 – wire for limiting the travel of expander, 11 – upper wire, 12 - attachment ferrule, 13 – rear wire, 14 – links. (Dan Antoniu/Horia Stoica collection)

The wires seen in the photos and the drawing were intended to adjust the skid alignment. To reduce drag in flight, the skid had to be laid horizontally - the rear wire was then fully tensioned and the front wire shortened by the expander. After landing, the skid had to be tilted backwards, which had the effect of loosening (and sagging of) the rear wire and lengthening the front wire thanks to the expander. (Dan Antoniu/Horia Stoica collection)

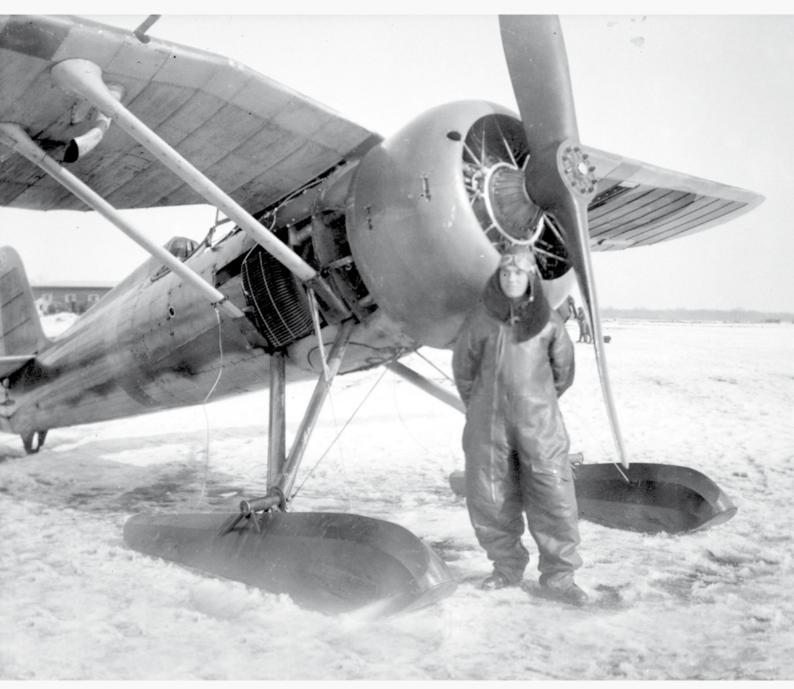
P.11F in the winter of 1940/41 with the final type of skis. Visible is the N-shaped truss protruding from the top of the fairing and the arrangement of wires adjusting the position of the skid. This suggests that the version with fairings was a development of an earlier form of ski, shown in the drawing above. (Dan Antoniu/Horia Stoica collection)

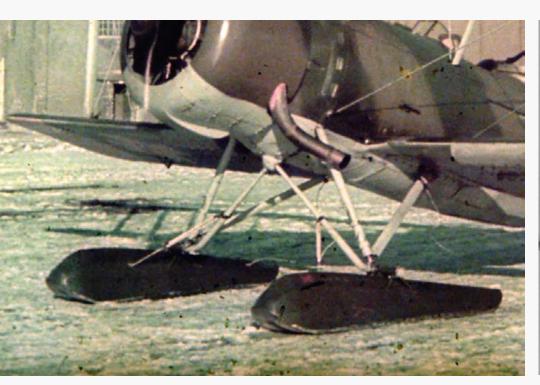
Photo at left shows the aerodynamic skis on the SET-7KB airplane and gives us important information on their overall green finish with metal strips visible underneath. Worth noting is also a very heavy sagging of the rear wire, much more pronounced than in the PZL fighter. This resulted in a different alignment of the skis during flight than in the P.11F. The very rare photo at right (unfortunately there is no better frame available) illustrates this well. As the pilot had no means of controlling the length of the wires, this alignment of the skids was almost certainly not dedicated specifically for landing, but was typical for all stages of the flight of this airplane. The arrangement seen on the SET-7 provided safer landings, but definitely reduced the maximum speed of the aircraft, which, however, was not an issue in this case. (Dan Antoniu/Horia Stoica collection)

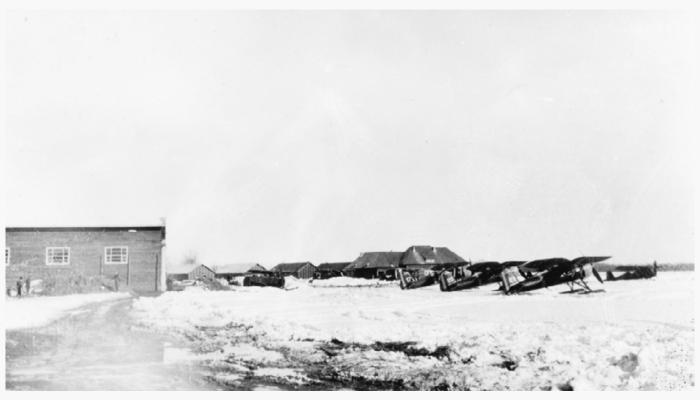
A slightly earlier photograph, taken on 1st February 1941. Four P.11F can be seen with skis installed. On the left, the hangars known from the previous photo. In the background, directly behind the aircraft is the 'Pavilionul Administrative' - the administrative building. This was a fairly typical structure, also known from other airfields in Romania. (Tomasz Kopański collection)

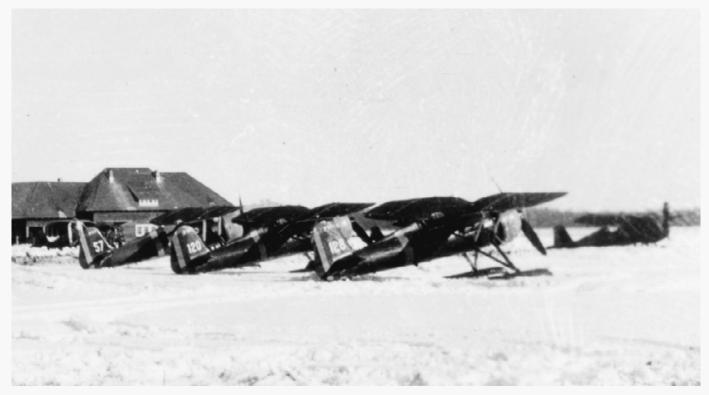
A close-up view of the parked P.11F fighters. No 57 is distinguished by its lighter camouflage colour, most likely terracotta or khaki-yellow. Typical markings of the time are visible on all three aircraft - cockades, 25cm yellow stripes on the wings and fuselage, yellow engine covers. (Tomasz Kopański collection)

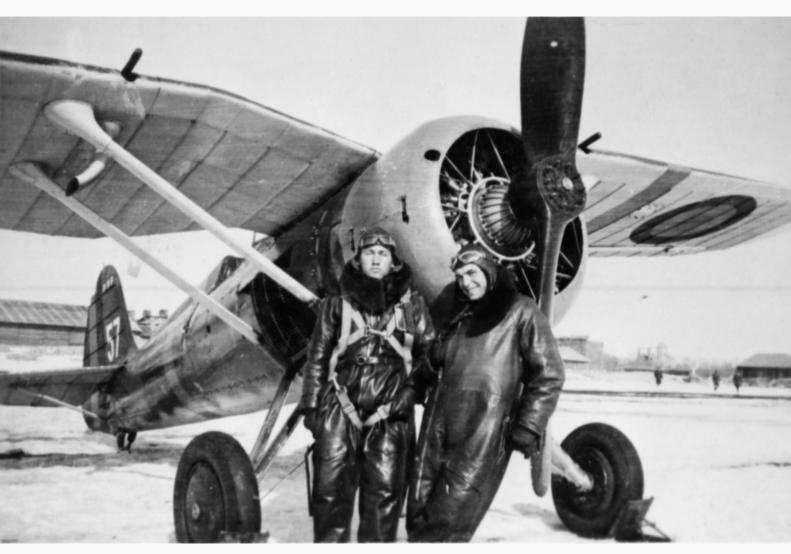
There is snow, but there are no skis! In fact this photo was taken in the winter of 1940-41 before the skis were installed or after they had already been replaced with wheels. It also reminds of the fact that aeroplanes with wheeled undercarriage can take off and land on snow, but there are additional risks involved. Interesting details include the markings mentioned earlier, white number '57' and the inscription 'P 11 F' on the fin. Well visible is the way the wing struts were painted, note also that undercarriage legs were blue-grey on the underside, but covered in camouflage on top. Both outer and inner wheel surfaces were painted most likely dark olive green. Propeller nut was left natural metal. Bomb racks of the IAR-Barbieri system are visible under the wings. (Dan Antoniu/Horia Stoica collection)

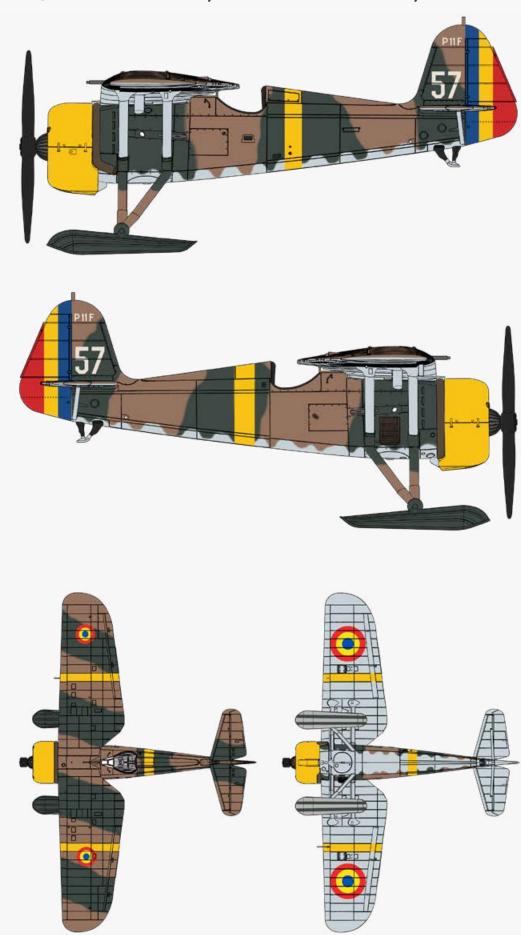
PZL/I.A.R. P.11F NO. 57, FLOTILA 2 VÂNĂTOARE, EARLY 1941

In the second half of 1940 the Romanian fighter fleet began to be repainted in two-tone camouflage, in case of No. 57 of the 'stripes' type. In all probability top colours were dark olive green and terracotta (although the latter could also have been khaki-yellow). Undersurfaces were blue-grey. Aircraft sported a full set of recognition markings that were mandatory at the time: cockades on the wings, tricolour on the rudder, yellow 25cm bands on the wings and fuselage (introduced in October 1940 as a recognition aid for German airplanes operating from Romania) and yellow engine cowling.

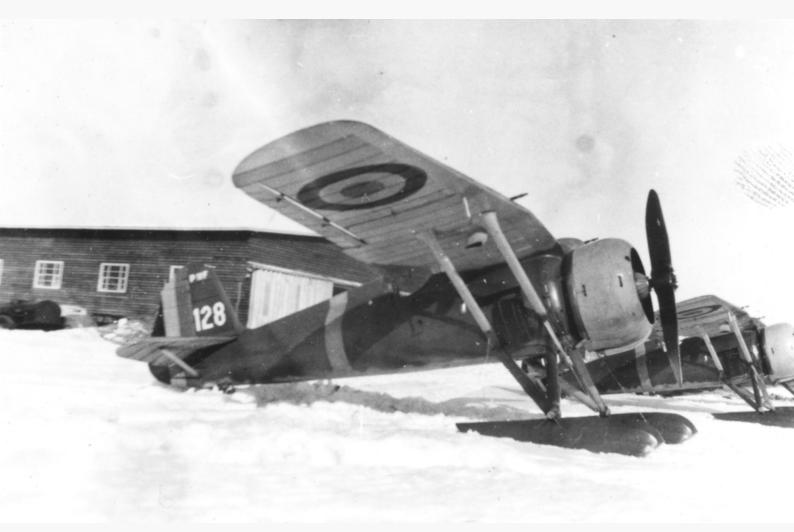
Photo of No. 128 taken on 20th January 1941. The wavy division line between the upper and undersurface colours on the fuselage is typical for the 'stripes' camouflage. The location of the yellow stripe on the fuselage is clearly visible, but the type of photographic material makes the stripes on the wings very faint. It is worth noting the way the wing struts and landing gear legs are painted. Aircraft number 120 is in the background. (Tomasz Kopański collection)

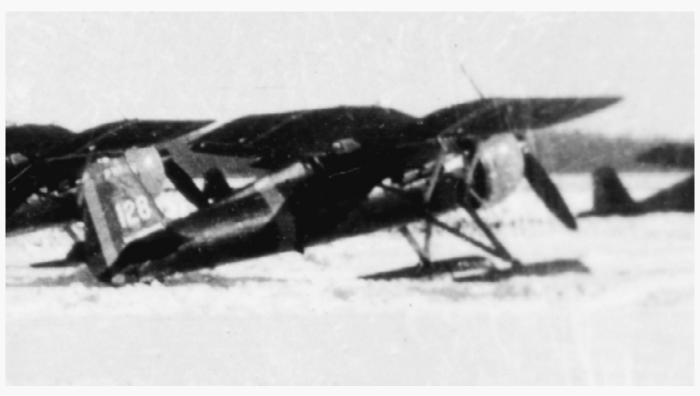
Close-up of aircraft No. 128 from the photograph shown in the section on No. 57. Visible are the markings on the upper surfaces of the wings - cockades and yellow stripes. (Tomasz Kopański collection)

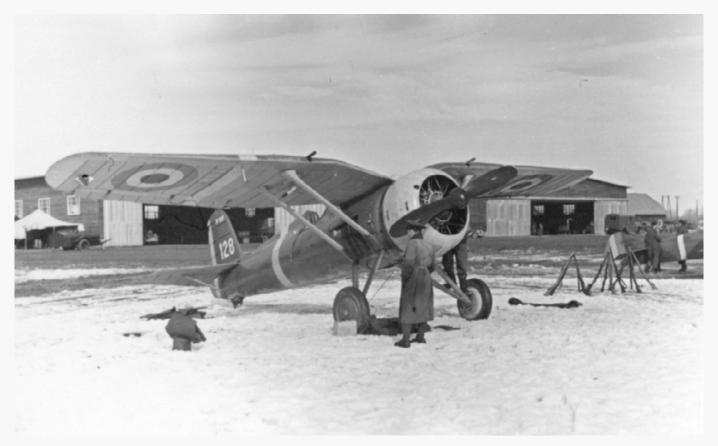
Final photo of this aircraft taken in the winter of 1940-41 again proves that minimal amounts of snow do not necessarily warrant switching to skis. The location of the underwing cockades and stripes on the wings can be seen well. Note the natural metal propeller nut and the manufacturer's logo on the blades. This airplane has a small-bomb or grenade dispenser installed inside the wing (with a sliding cover). Unlike No. 57, the inner surfaces of the wheels are painted blue-grey. (Tomasz Kopański collection)

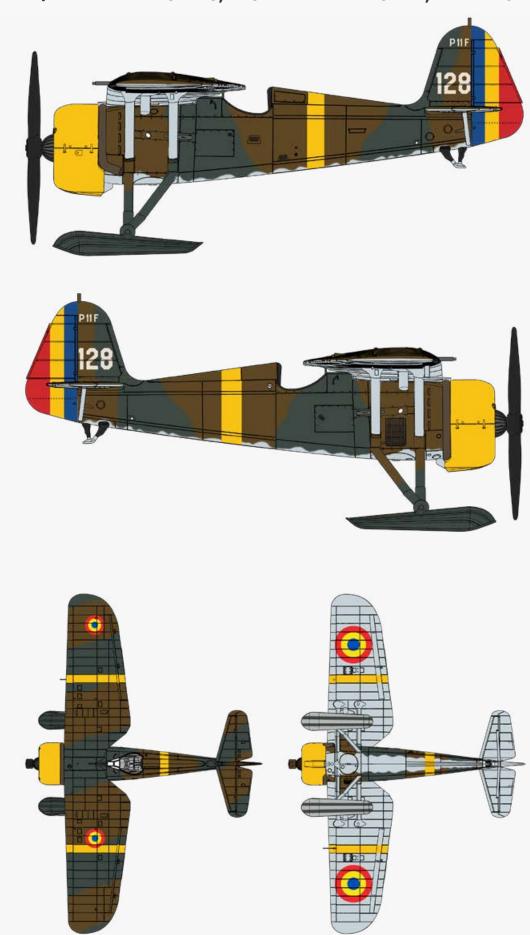
PZL/I.A.R. P.11F NO. 128, FLOTILA 2 VÂNĂTOARE, EARLY 1941

Although repainted at approximately the same time as No. 57 and in the same general camouflage scheme, there are some differences between the two airplanes. The first one

is the use of a darker colour next to the dark olive green - most likely dark brown or khaki-brown. The standard set of markings consists of cockades on the wings, a tricolour on the rudder, a yellow engine cowling and 25cm stripes on the wings and fuselage, but the latter was placed further to the rear than on the No. 57. Finally, the propeller manufacturer's logo is also different.

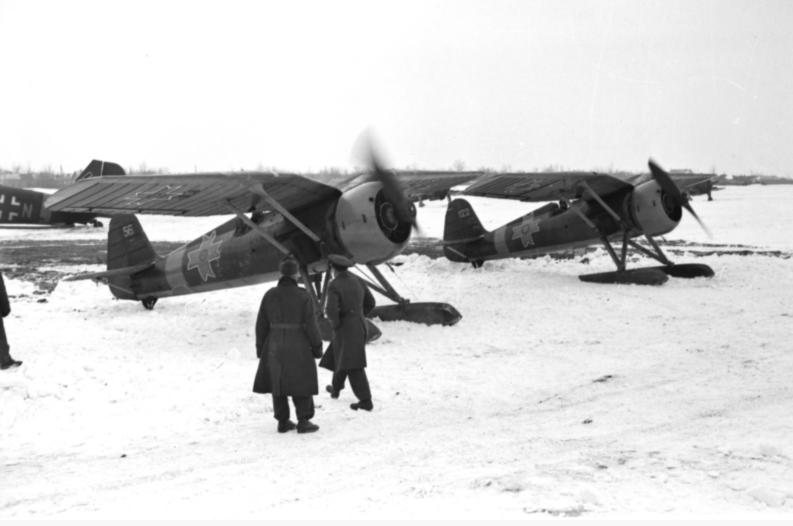
Aircraft No. 56 and No. 122 being prepared for take-off during the winter of 1942-43. The airplanes bear markings typical of the period - crosses on the fuselage and wings, yellow engine covers, 50cm stripe on the fuselage and yellow wingtip undersurfaces (in case of the latter, they blend with the blue-grey on the black and white photographs). Note the difference in colour of the central dot between crosses on the fuselages, much lighter on aircraft No. 122. (Dan Antoniu/Horia Stoica collection)

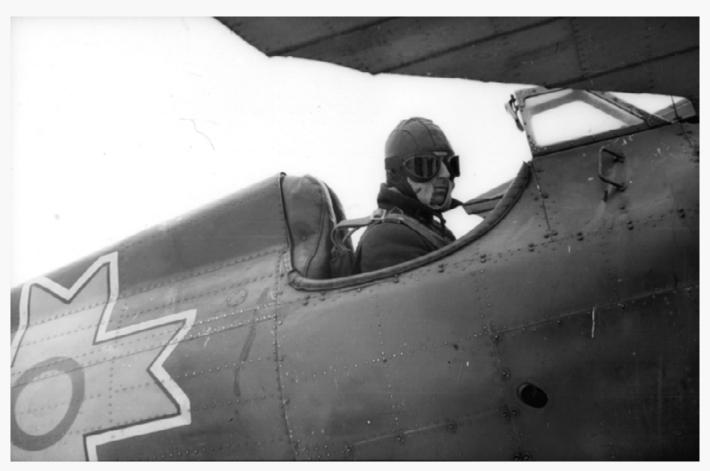
Close-up of the cockpit. Just behind the pilot's headrest a circular skin patch can be seen where the antenna insulator was previously fitted (the aircraft had no radio installed). Note the wear of the paintwork and the fact that the cross on the visible right side of the fuselage was slightly further back than on the left side. (Dan Antoniu/Horia Stoica collection)

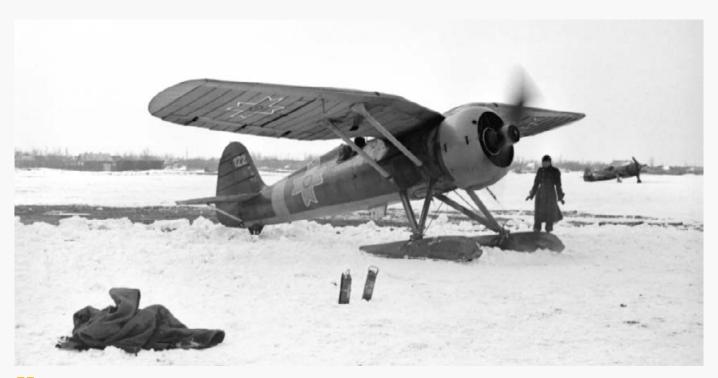
Last moments before take-off. In front of the aircraft two fire extinguishers can be seen. They were always kept on standby during engine start-up. This photo shows that, unlike the fuselage, the crosses on the lower surfaces of the wings had dots in the same colour as the cross rim. The aircraft had the armament removed, but the holes in the wings were not covered with plugs. Same as No. 128 this airplane has a small-bomb or grenade dispenser installed inside the wing (with a sliding cover). (Dan Antoniu/Horia Stoica collection)

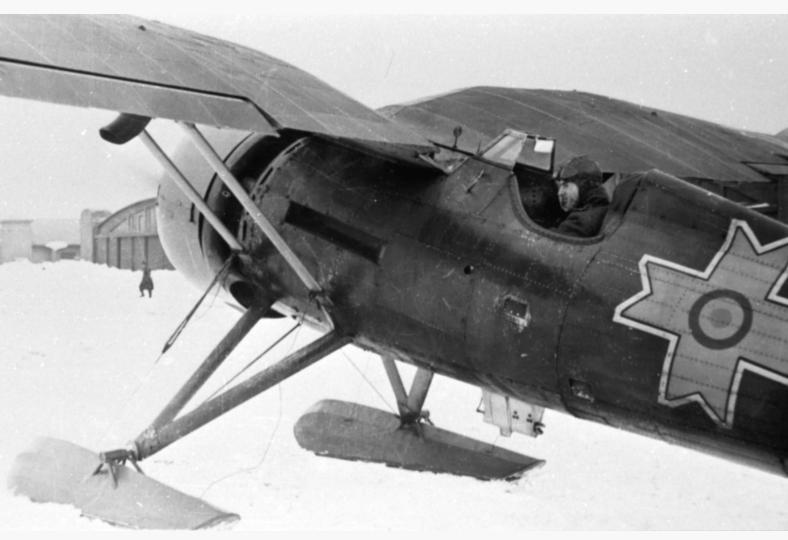
This view gives us a good insight into a non-standard element under the fuselage, most probably an attachment for towing air targets. The presence of the gunsight is notable, especially as the armament has been removed. Typical of the ski position of an aircraft standing on the ground, the rear wire is not tensioned. It is also worth looking again at the national markings on the fuselage - the central blue dot is noticeably lighter than the blue rim of the cross. A close examination of the buildings visible in the series of photographs taken on this occasion (of which only part is published here) allows us to conclude that they were taken at Galaţi airfield. (Dan Antoniu/Horia Stoica collection)

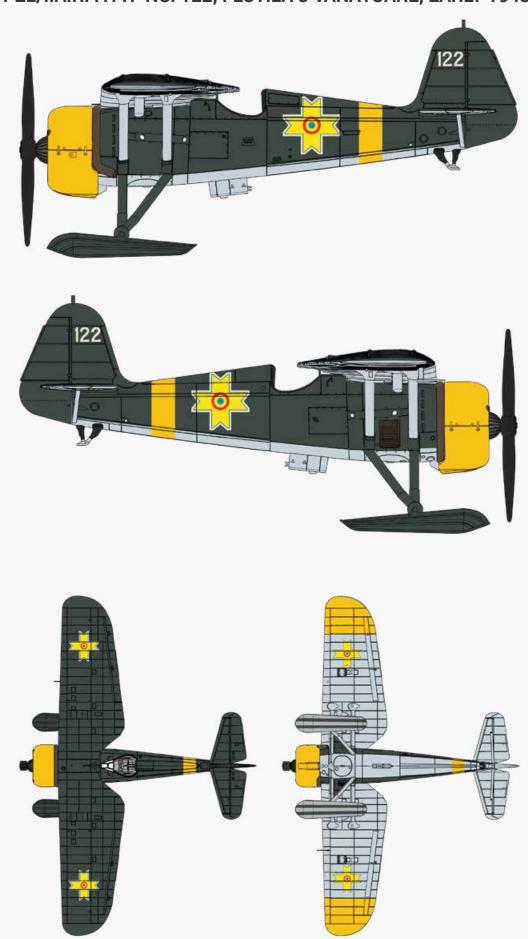
PZL/I.A.R. P.11F NO. 122, FLOTILA 3 VÂNĂTOARE, EARLY 1943

Airplane No. 122 was finished in uniform dark olive green on the upper surfaces, a scheme that replaced the twocolour camouflage in late 1942. Characteristic feature of the new scheme (but not exclusive to it) was the straight dividing line between the upper and underside colours. The aircraft sported full set of markings mandatory at the time: crosses (introduced in May 1941), a yellow 50cm stripe on the fuselage and wingtips undersides in the same colour (introduced in June 1941 in connection with Operation Barbarossa) and a yellow engine cowling (reintroduced in September 1941).
